Sunnyside Gold Corporation San Juan County, Colorado		DATE: 02/25/93
Relationship of Mine Workings to Surface Water Basins		DESIGNED:
		CHECKED:
		APPROVED:
		DRAWN: RAS
		PROJ.: 187112251

San Juan County Mining Venture Silverton, Colorado	DATE: 10/23/91
Schematic of Differing Fracture Permeability With Depth	DRAWN: DRD
	CHECKED:
	APPROVED:
	DWG NO:
	PROJ.: 464110381

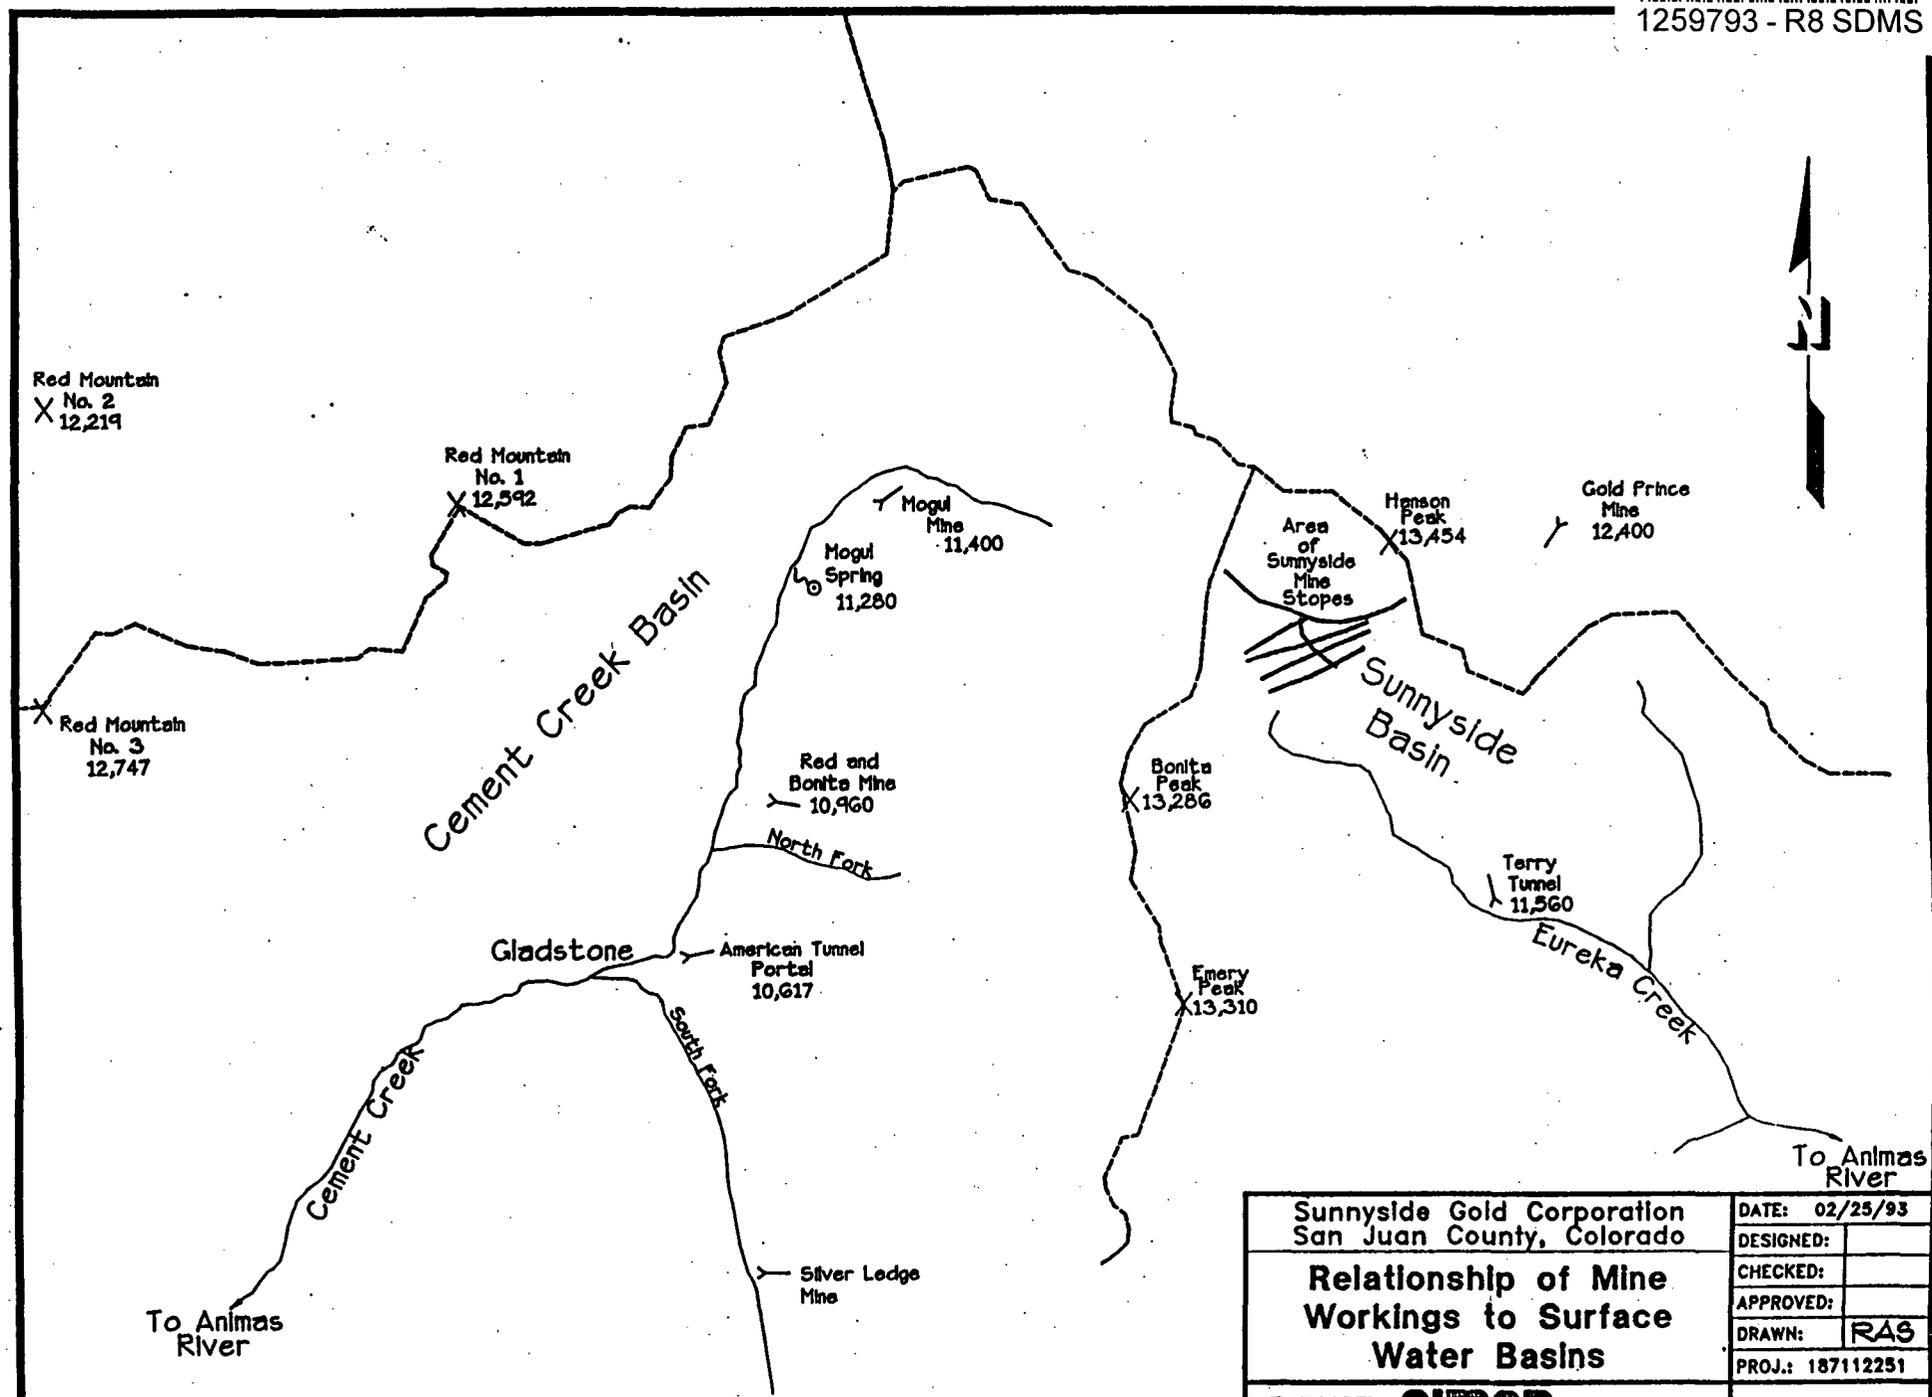
Figure 2

Note: Locations of stopes in Sunnyside Basin are generalized.

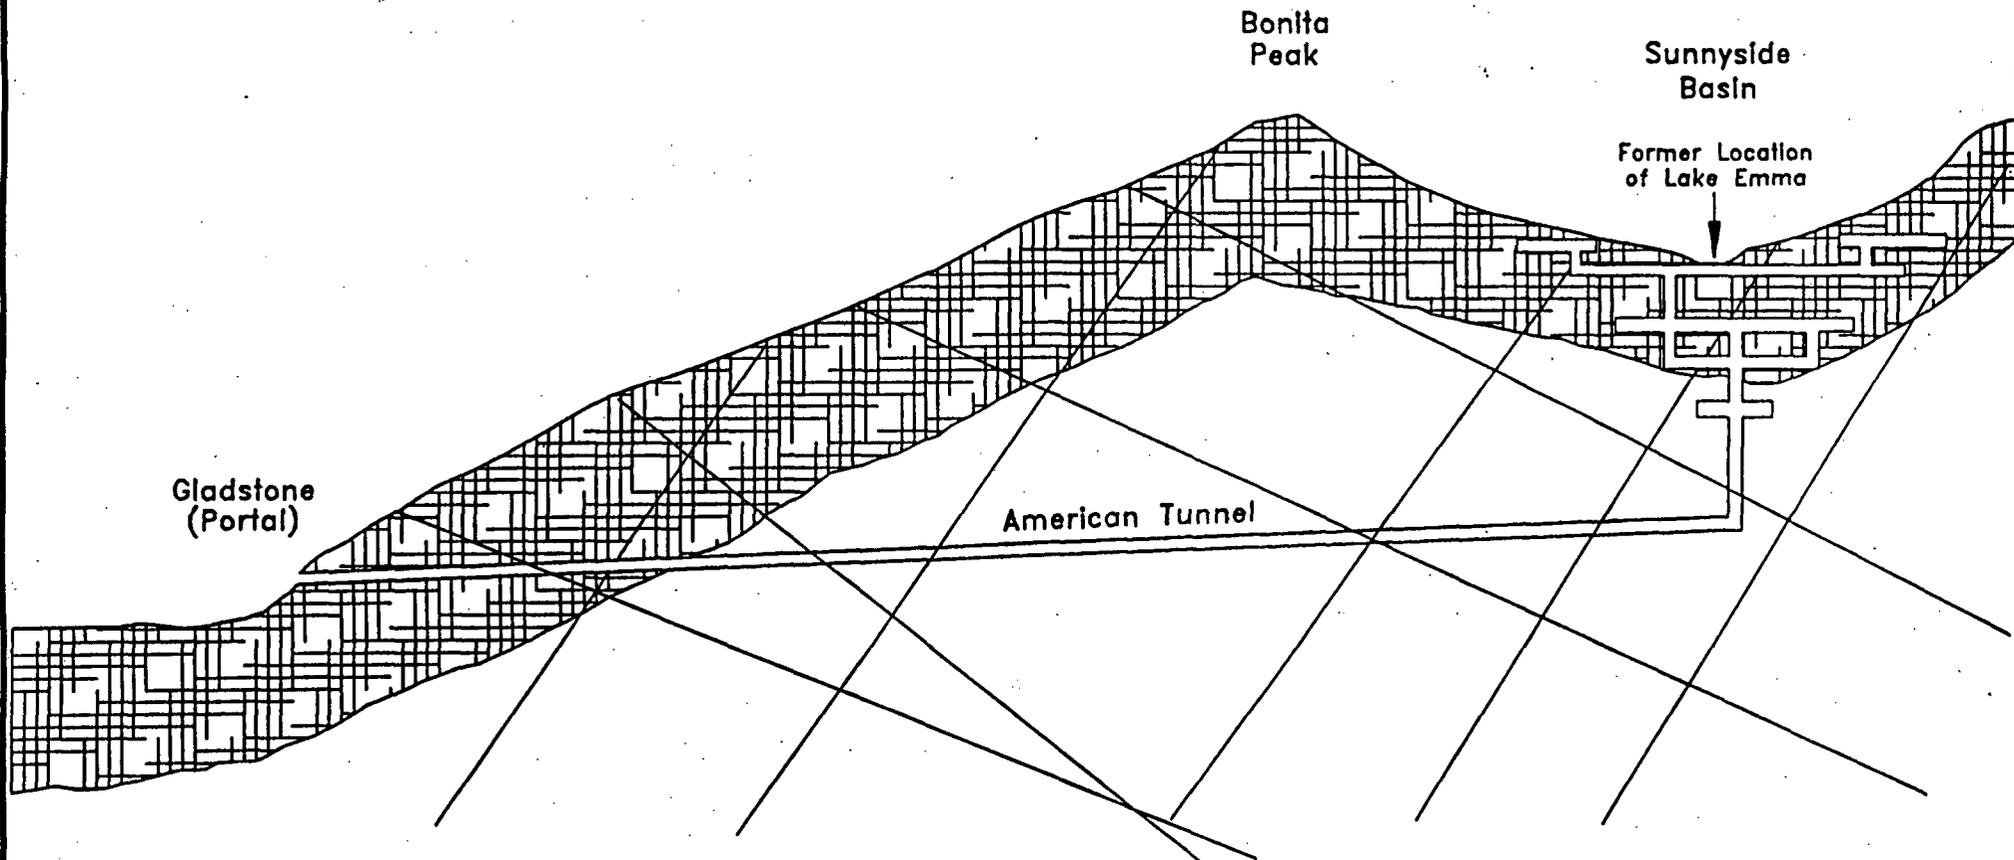
Figure 6

Zone where minor fractures transmit significant quantities of water.

Major fractures which transmit water even under considerable overburden pressure.

Mine workings.
